Home Inspection Report

123 ABC Drive, Senoia , GA 30276

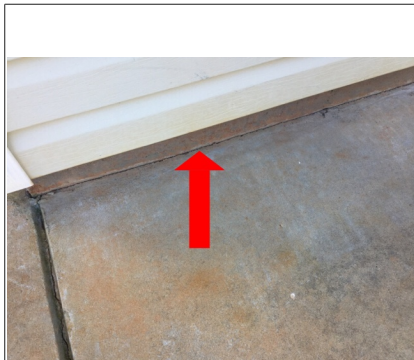
Recommend sealing where patio meets house slab. Due to slight settling, a small gap has been created between slab & patio.

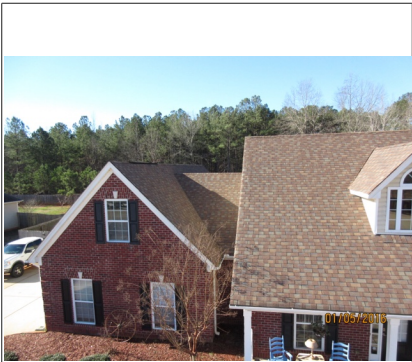
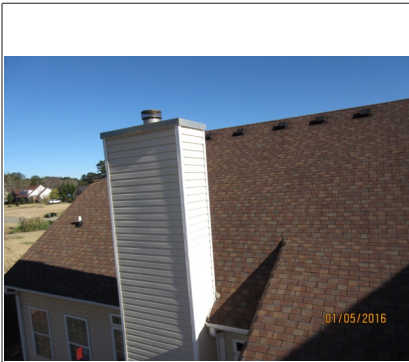
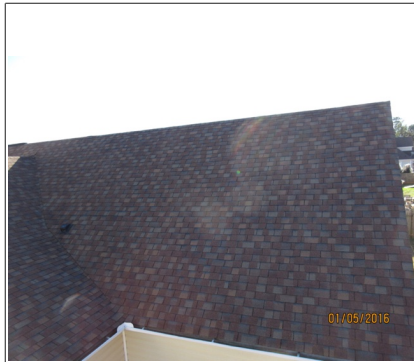
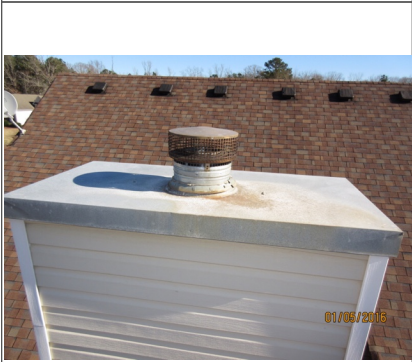
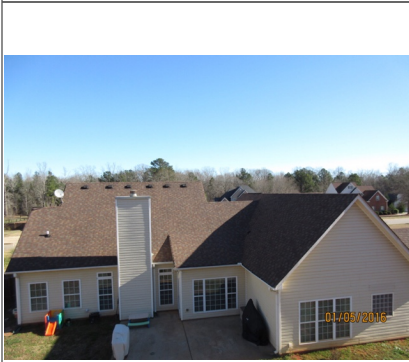
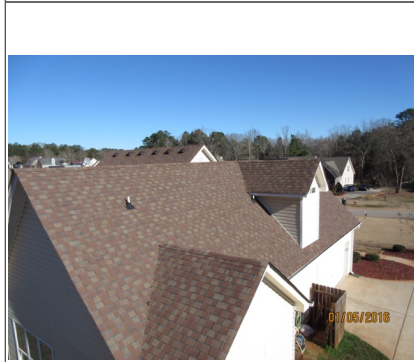
Chimney cap in satisfactory condition at time of inspection.

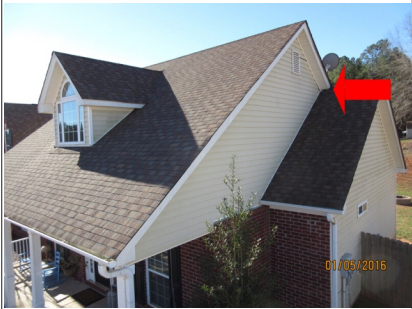
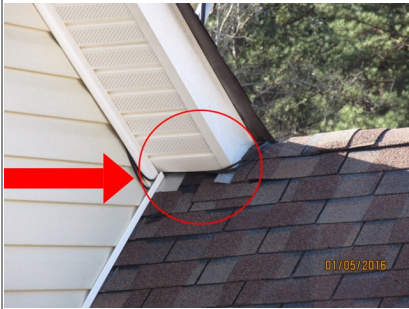
This area has a missing shingle. This is a possible point of future water leakage if not repaired.

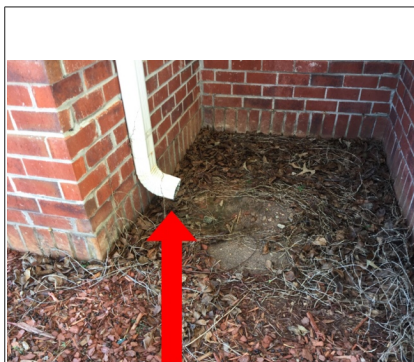
Recommend gutter extension in this area to divert rain water from pooling against foundation.

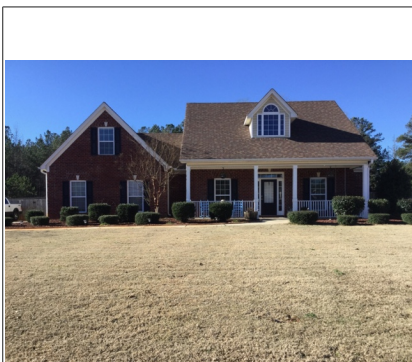
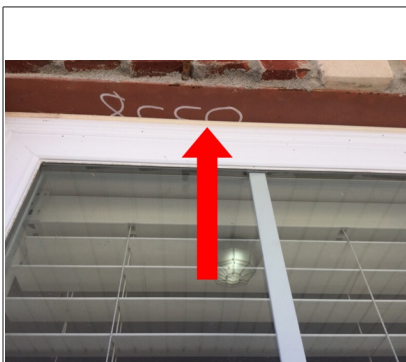
Recommend painting steel lintels above all windows. If they are not painted, they can rust as well as expand due to moisture and crack surrounding brick veneer and mortar.

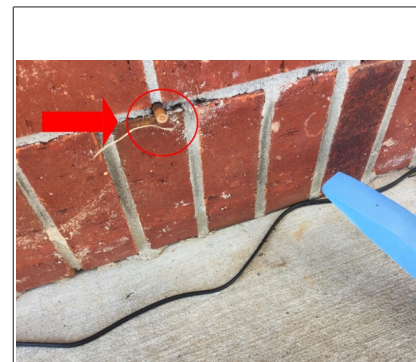
Recommend cleaning out weep holes above windows and along bottom of house on front of home. Weep holes are only on brick veneer. These can be cleaned with a small nail and pipe cleaner. If they stay clogged, it will not allow the moisture that has penetrated the brick to drain out. Recommend repair.

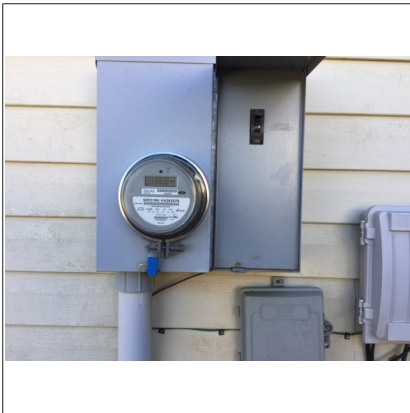
Building(s) Exterior Wall Construction

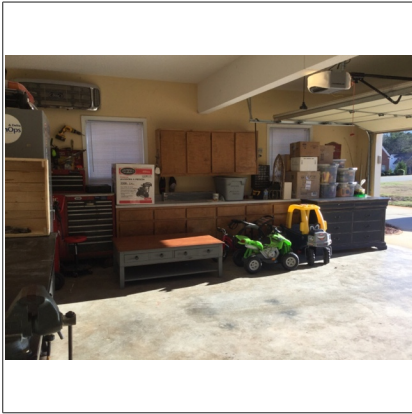
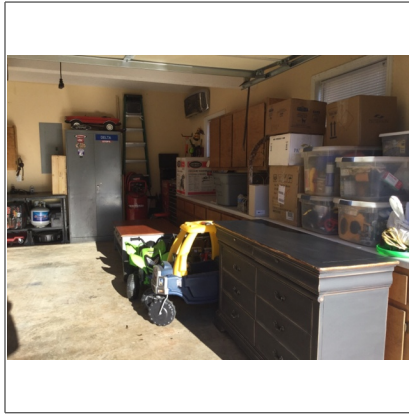
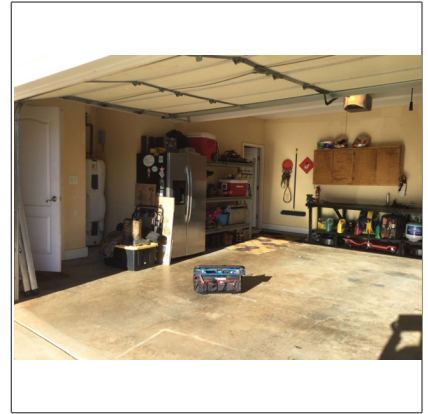
Fire Separation Walls & Ceiling

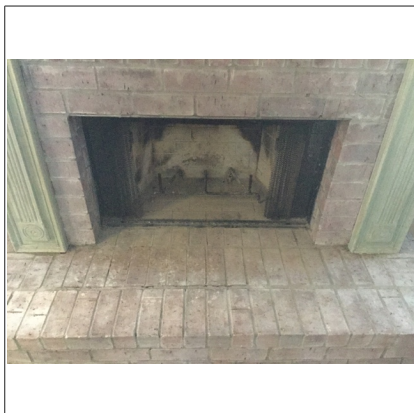
Stairs/Steps/Balconies

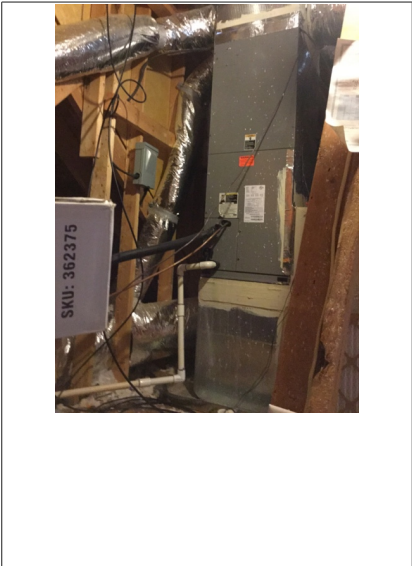
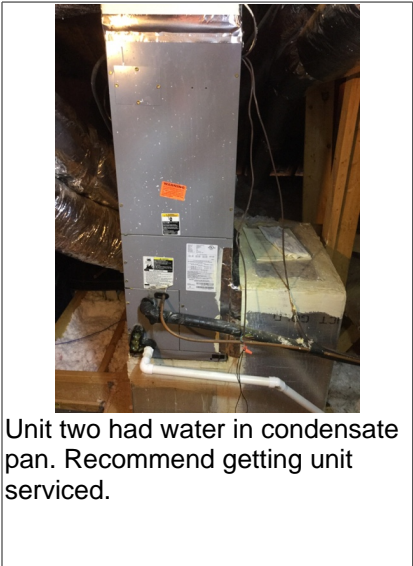
Unit two had water in condensate pan. Recommend getting unit serviced.

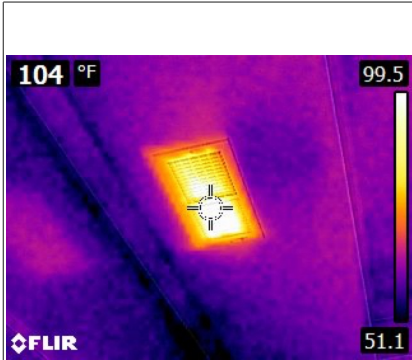
Heating was working properly at time of inspection. Cooling could not be tested due to the units being heat pumps and the outside temperature.

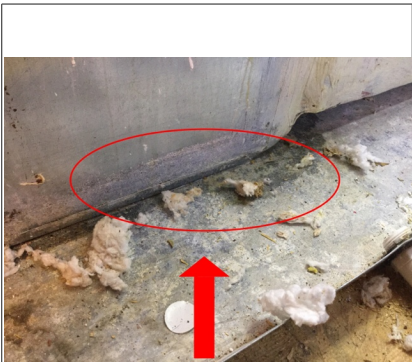
Fresh water found in emergency condensate pan at time of inspection. Recommend licensed HVAC technician evaluate & service attic unit for left side of home.

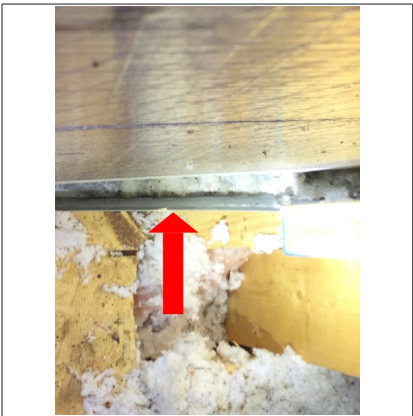
On same unit in attic for left side of home. Wet insulation was noted in emergency condensate pan behind unit. Recommend repair.
